Advanced Vibration Analysis Techniques for Diagnosing and Repairing Systemic Machine Faults on Tactical Power Sources

David Aebischer
Cintel Inc., Systems Engineering and Integration
Huntsville, AL, USA, 35808
Dave.aebischer@cintel-inc.com/ 1-931-220-8541

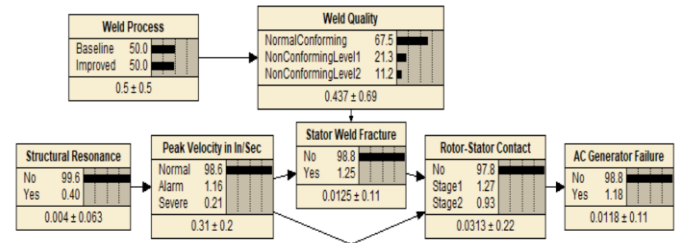
In this phase also began the process of eliminating the LS trailer, the PAK, and weld penetration/quality as covariates for the stator weld failures and subsequent generator failure. The team performed the same CCP tests in all configurations - on/off LS; with/without PAK - and noted no significant difference in values in any combination. This result was not conclusive but suggested that the LS trailer and PAK did not have a direct effect. For the weld quality, the analysis team performed CCP on AMMPS with original stators (pre-production process improvement) and improved stators (post-production process improvement). Data from these tests showed no significant difference between stator types. The team modeled this accordingly in the BN as a structural indirect causal connection from the resonance to the weld to rotor-stator contact to main generator failure. In this model, weld quality values have a moderating effect, wherein suboptimal welds would be more susceptible to failure and optimal/conforming welds would make other vibration-related failure mechanisms more probable, e.g., rotor-stator contact from any of the following individually or in combination: first bending mode action, bearing failure, or winding bond failure.

Figure 1. *Bayesian Network (BN) showing the causal relationships between structural resonance, stator weld, and AC generator variables.*

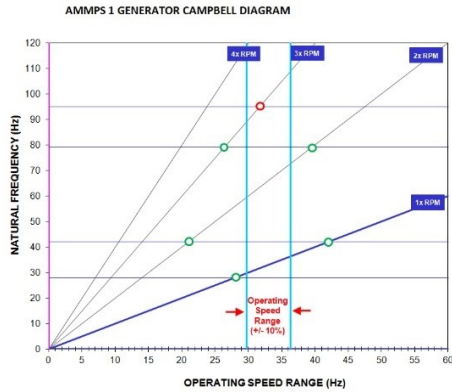
Figure 2. *Campbell Diagram: Representative of Baseline OEM Configuration and OEM with PAK, both on and off LS, Configurations. Fn are relative to Turning Speed (2000 RPM/33.3 HZ) and multiples of Turning Speed (TS). Red, or Bold, circles indicate major amplification points relative to the 10% band around TS*

The 3 x TS peak (~ 96 HZ, in Red), located within the +/- 10% of TS band was indicated for follow-on ODS testing to characterize the movement of the AMMPS at turning speed. To further evaluate the effects of the different AMMPS configurations on the structural dynamics of the AMMPS, the EMA tests were all repeated for the different configurations of on/off LS, PAK/No PAK, and original weld/improved weld. The EMA data from these tested indicated a sharp null of no effect and effectively eliminated the PAK and LS variables from consideration as covariates for the stator weld fractures – further strengthening the arguments underpinning the structural resonance hypothesis. These data did not alter the causal model as regards the potential moderating effect of weld quality.

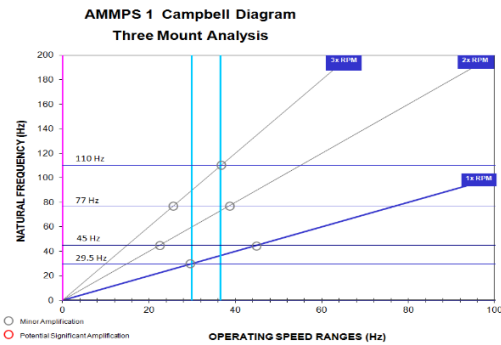
AMMPS 1 Campbell Diagram
Three Mount Analysis

Figure 3. Campbell Diagram: Treatment 1 Fn relative to Turning Speed (2000 RPM/33.3 HZ) and multiples of Turning Speed. Clear circles indicate minor amplification points relative to the 10% band around turning speed. Note absence of any points inside of +/- 10% of TS and absence of red, or bold, circles.

In this phase Cintel used the combined EMA and ODS results to determine optimum location and geometry of a stiffening bracket designed to move the 3 x TS FN out of the +/- 10% significance band around TS. The existing AMMPS configuration uses two sets of isolators: one set under the engine; one set under the stator. Both sets are affixed to brackets. The engine bracket is part of the engine casting; the generator bracket is welded to the stator frame. Each bracket is fitted with a rubber shock mount to isolate the engine/generator from the frame. The Team determined that the existing engine block boss used to mount the transportation bracket - located at the approximate antinode between the engine and generator - would be a viable location. This effectively created a "middle row" set of brackets (with shock mounts) to stiffen the structural beam created by the engine and generator. After fabricating and installing the prototypes, Cintel repeated the EMA test, and these test data showed the brackets were successful in moving the Fn out of the TS band (Figure 3.)

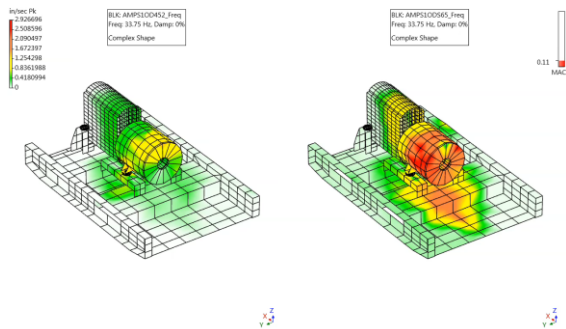
Figure 4. ODS Animation: Snapshot of AMMPS at 33 HZ with amplitude shown on color scale and in inches/sec in Black and White. The snapshot on the right is the Treatment 1 configuration with just the brackets. Note that with only the stiffening bracket there is significant decrease in vibration energy but still some moderate peaks (velocity = ~ 1.6 ips.). The snapshot on the left is the Treatment 1 + 2 configuration with the brackets and 50 durometer isolators. Note the significant decrease in amplitude and vibration energy with the combined treatment (velocity = ~.1 ips)

In this phase, Cintel first performed another ODS test on the new baseline configuration with stiffening brackets to assess the impact of the brackets on the AMMPS movement at turning speed. These test data showed a significant improvement (decrease in vibration energy) but also showed that further stiffening would not be effective. The ODS showed that a moderate damping treatment-decreasing the isolator shock mount durometer value - could improve performance by reducing the magnification factor, or Q factor, around TS. Figure 4 shows the effectiveness of replacing the existing 70 durometer mounts with 50 durometer mounts.
